DEPARTMENT OF TRANSPORTATION**DIVISION OF ENGINEERING SERVICES**

Contract #: 04-0120F4Cty: SF/ALA Rte: 80 PM: 13.2/13.9File #: 1.28**WELDING INSPECTION REPORT****Resident Engineer:**Siegenthaler, Peter**Address:** 333 Burma Road**City:** Oakland, CA 94607**Report No:** WIR-021487**Date Inspected:** 03-Mar-2011**Project Name:** SAS Superstructure**OSM Arrival Time:** 700**Prime Contractor:** American Bridge/Fluor Enterprises, a JV**OSM Departure Time:** 1930**Contractor:** American Bridge/Fluor Enterprises, a JV**Location:** Job Site

Caltrans Office of Structural Material (OSM) Quality Assurance Inspector (QAI) Joselito Lizardo was present at the Self Anchored Suspension (SAS) job site as requested to perform observations on the welding of components for the San Francisco Oakland Bay Bridge (SFOBB) Project.

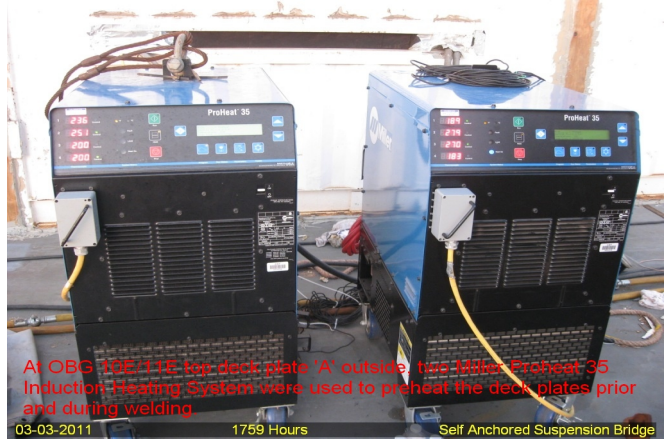
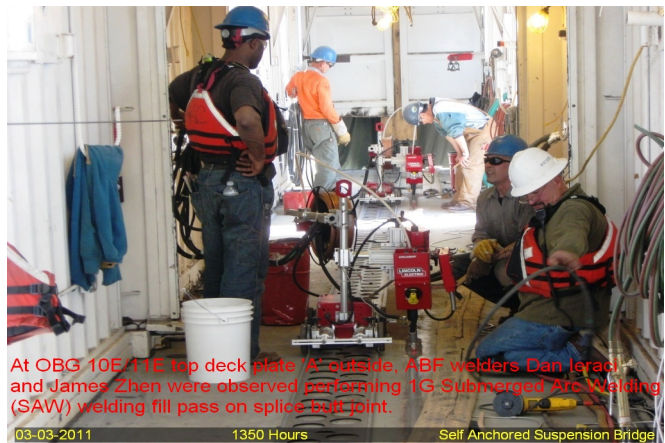
At OBG 10E/11E top deck plate 'A1 to A5', QA randomly observed ABF certified welders Dan Ieraci and James Zhen perform 1G (flat position) Submerged Arc Welding (SAW) on the splice butt joint. Welder Dan Ieraci was noted welding from A1 to A3 while welder James Zhen was noted welding on A3 to A5. The welders were utilizing F7A6-EM12K-H8, 3.2mm electrode with corresponding Esab OK Flux 10.62 flux and implementing Caltrans approved Welding Procedure Specification (WPS) ABF-WPS-D15-4042B-1. The joint being welded had a single V-groove butt joint with backing bar. The plates were preheated to more than 150 °F using Miller Proheat 35 Induction Heating System located on top of the plate prior welding and moving it the side during welding. ABF/QC William Sherwood was noted monitoring the welding parameters of both welders. QA noted the welding parameters, the workmanship and appearance of the completed cover deemed satisfactory. At the end of the shift, SAW cover pass welding was completed where the track mounted SAW wire feeder has access.

At OBG 9W/10W side plate 'E1' inside, QA randomly observed ABF/JV qualified welder Sungtao, Huang ID # 3794 continuing to perform CJP groove (splice) welding fill pass on the splice butt. The welder was observed perform automatic welding in the 3G (vertical) position utilizing a dual shield Flux Cored Arc Welding (FCAW-G) with E71T-1M, 1/16" diameter wire electrode and implementing Caltrans approved Welding Procedure Specification (WPS) ABF-WPS-D15-3042B-1. The joint being welded has a single V-groove butt joint with backing bar. The splice joint was preheated and maintained to greater than 150 degrees Fahrenheit using

At OBG 8W-PP70.5-W5-SE deck access hole to top deck plate inside, QA randomly observed ABF/JV qualified welder Jorge Lopez perform CJP repair welding. The welder was noted welding in 4G (overhead) position utilizing SMAW with 1/8" diameter E7018H4R electrode implementing Caltrans approved Welding Procedure Specification (WPS) ABF-WPS-D15-1001 Repair. The second time welding repair located at Y=3615mm and having 115mm long x 25mm wide x 7mm deep boat shape excavation profile was tested with Magnetic Particle Testing (MT) prior welding. During welding, ABF QC John Pagliero was noted monitoring the welder and his welding parameters. QA noted parameter during welding was 130 amperes which appears in compliance to the WPS. During the shift, welding repair at location mentioned above was completed and the welder has moved to 6E-PP37.5-E5-N deck access hole and performed back gouging using die grinder on the welded from inside butt joint. At the end of the shift, back gouging using die grinder was still continuing and should remain tomorrow.
